# Equipment Life Expectancy

## Phosphate Maintenance Roundtable

Advancing Sulfuric  
and  
Phosphoric Acid Plant Maintenance

2006

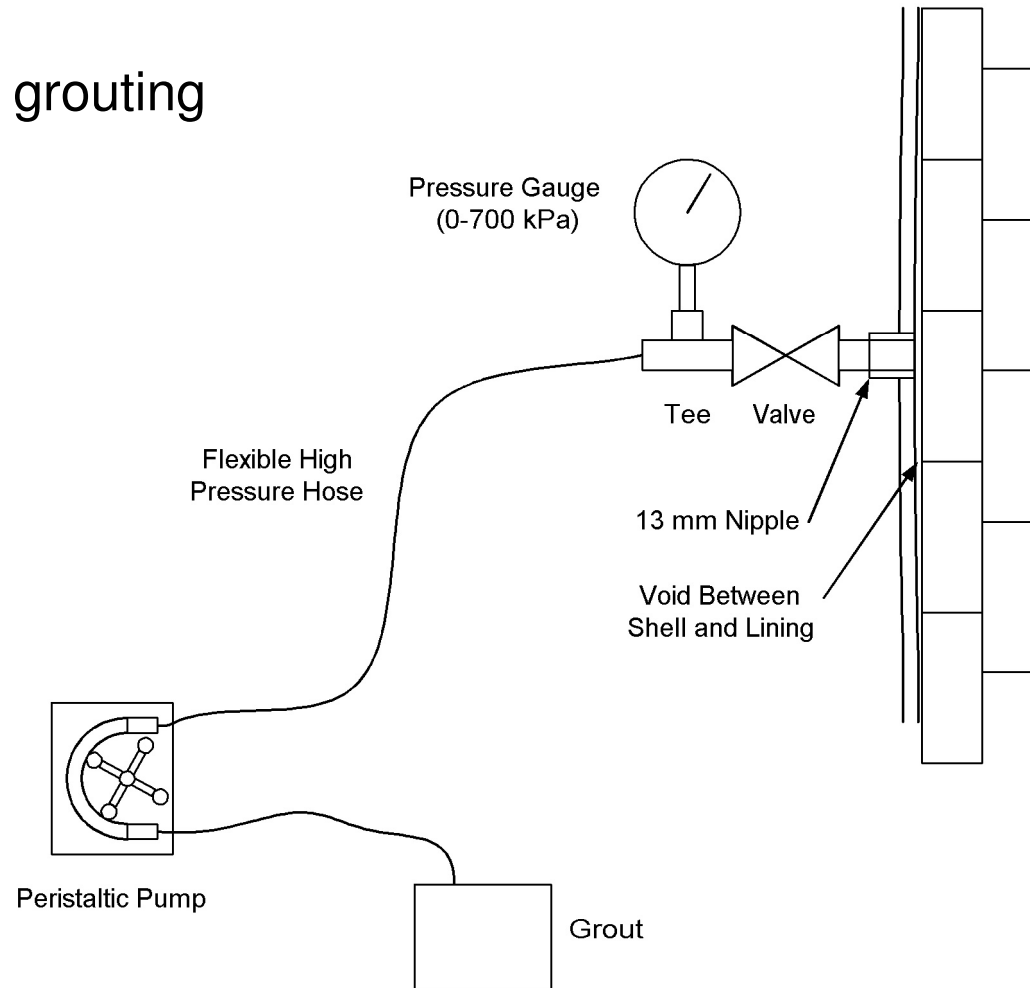
- Repair leaks by pressure grouting

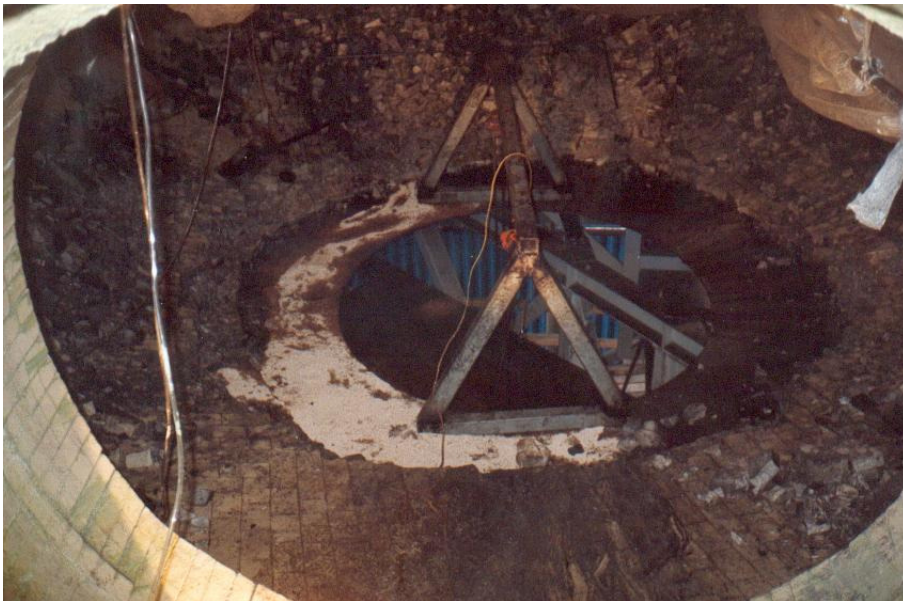
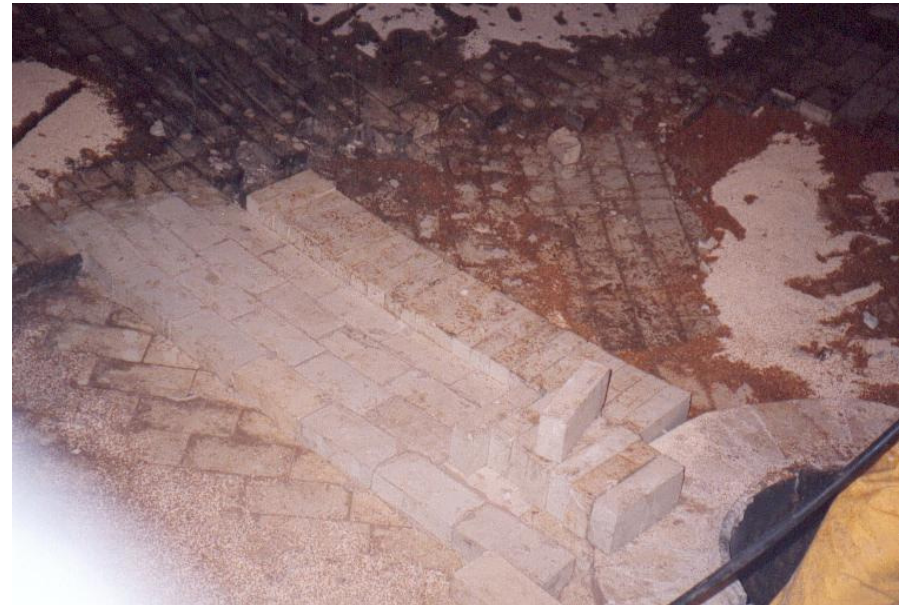
- Extensive repair of shell and re-bricking

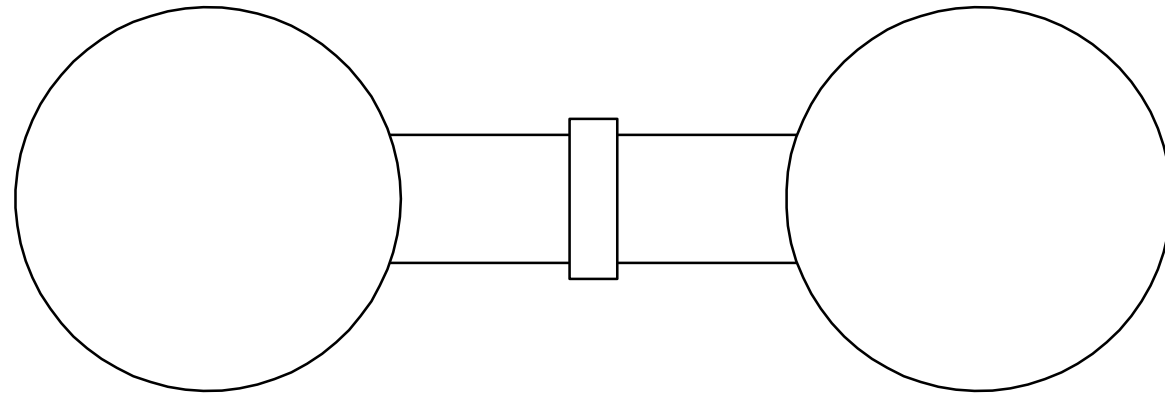
Plugged expansion joint  
will not compress so  
vessel shell deforms.

- Inspect ducting – thickness measurements
- Ensure thermal insulation is in good order
- Check low point drains on a regular basis
- Repair and patch
- Upgrade material
- Resolve process problems – mist elimination and carryover
- Ensure expansion joints are in good working order. Replace failed expansion joints.
- Ducting stress analysis

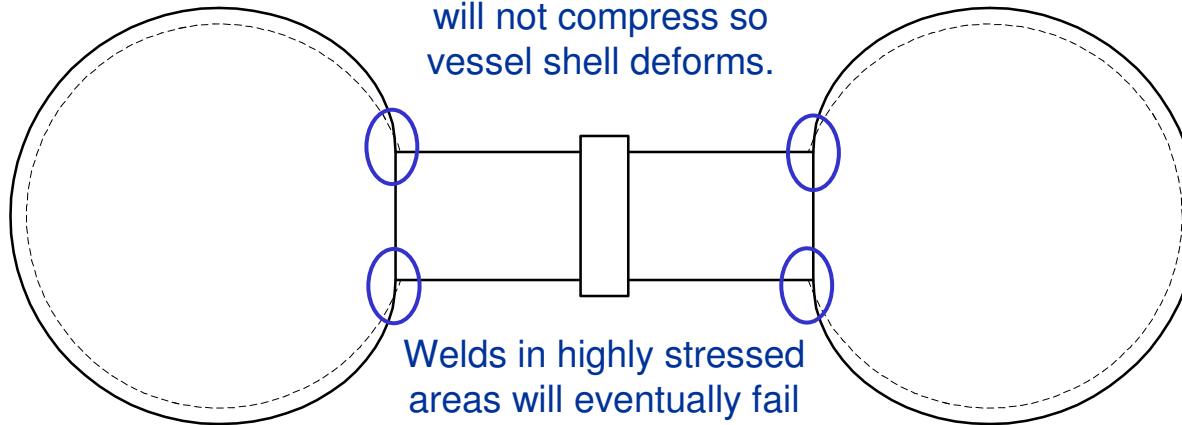
Welds in highly stressed  
areas will eventually fail  
resulting in gas leaks.
