## Challenge

Pitting of carbon steel tanks used for acid and caustic storage during demineralized water treatment had destroyed unprotected tanks within 3 years, requiring tank replacement.

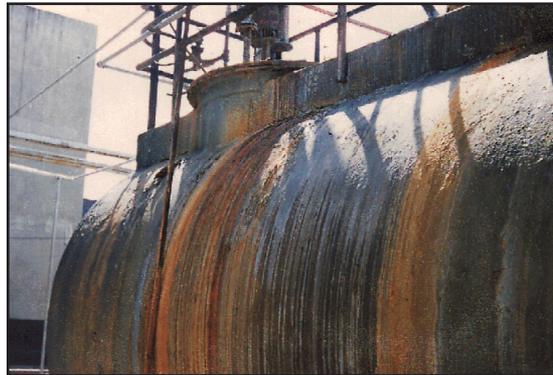
As tank level drops, 98% H<sub>2</sub>SO<sub>4</sub> in head space drops to <93%. Carbon steel is no longer resistant to corrosion at this level.

Corroded tanks, containing 98% H<sub>2</sub>SO<sub>4</sub>

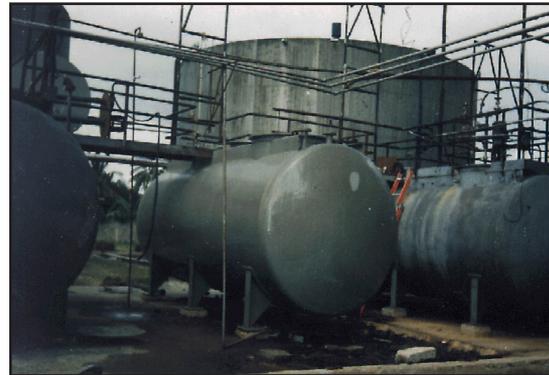
New tanks coated with ARC S4+ internally and ARC S2 externally

- Grit blast to Sa 2.5 with 3 mil (75 µm) angular profile

1. Stripe coat internal weld seam with 1 coat, followed by 2 coats **ARC S4+** in alternating colors with a total DFT of 30-40 mils (750-1000 µm)
2. Apply 2 coats of **ARC S2** with total DFT 20-30 mils (500-750 µm) on the tank exteriors

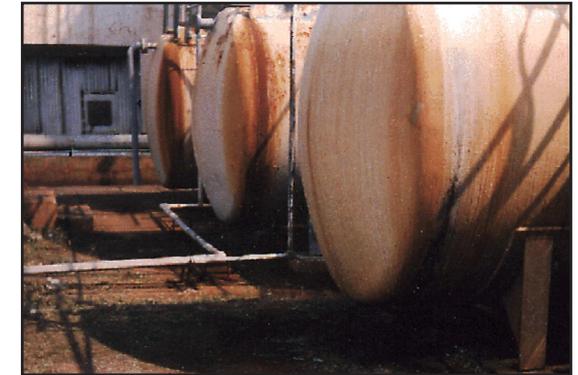
- After 36 months in service, no flaws could be found in the lined surface
- Some ultra-violet-light related chalking on externals. Aliphatic urethane coating applied to address chalking
- After 60 months tanks are still in excellent condition
- After 13 years of service, ARC coatings is preferred protection for these assets

After 13+ years, only chalking and staining is evident
