SULPHURIC ACID STORAGE TANK PROTECTED WITH BELZONA

Belzona coating internal surface of sulphuric acid storage tank diameter 2 metre height 2.5 metre

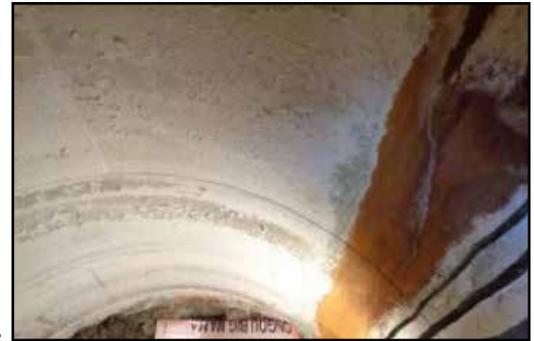
The internal surface that corrosion occur inside the tank.

1. Corrosion occur inside the tank
2. Carbon steel surface was prepared by grit blasting
3. Stop leak area with Belzona 1121 and Belzona 9341
4. Apply second coat of Belzona 4311
