PROJECT PROFILE

Project: Cajamarquilla Refinery

Location: Lima, Peru

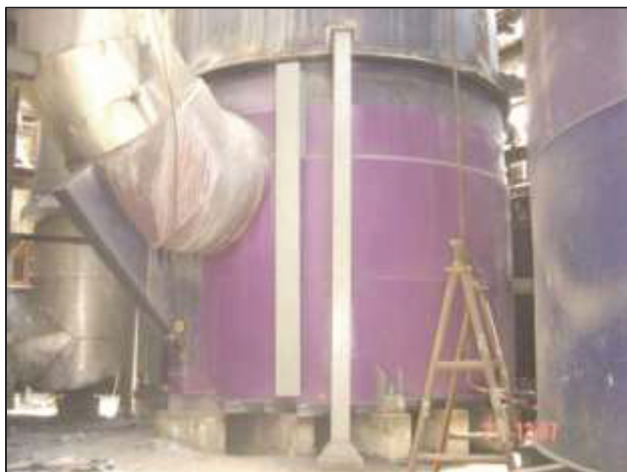
Tank jacket

- A drying tower located in the sulfuric acid plant had sprung a series of leaks. The leaks became apparent with sulfuric acid on the outside and surrounding area of the structure. The source of the problem was lack of a final lining in the interior of the tank. 54SG was chosen because it cures quickly enough to permit full chemical exposure within 48 hours. The polymer concrete jacket was designed at a thickness of 2 inches around the tower and was painted purple to aid in future inspections. A decade later, the jacket is still in excellent condition.
- Following the jacket project, 90, 65 and 54SG were used on the interior of the tower structure. This application has withstood years of corrosion without failure as well.

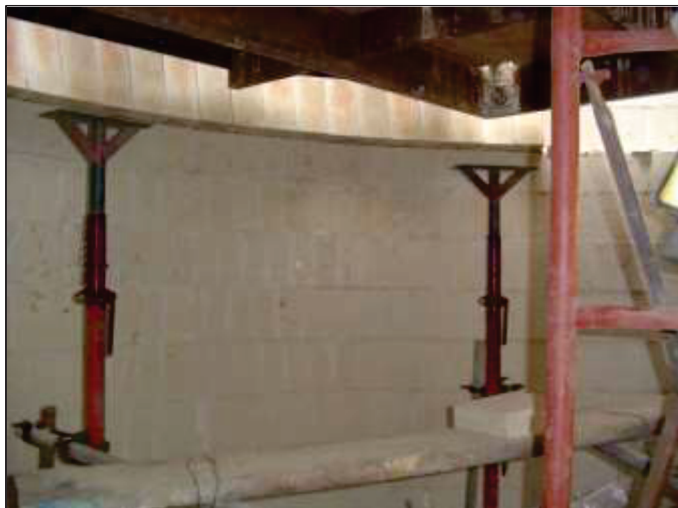
Interface between bottom of the tank and the wall - 90, 65, & 54SG
