ChemLine® Provides Sulphuric Acid Tank Storage Service for Chemical Company in Columbia

ChemLINE° CASE STUDY

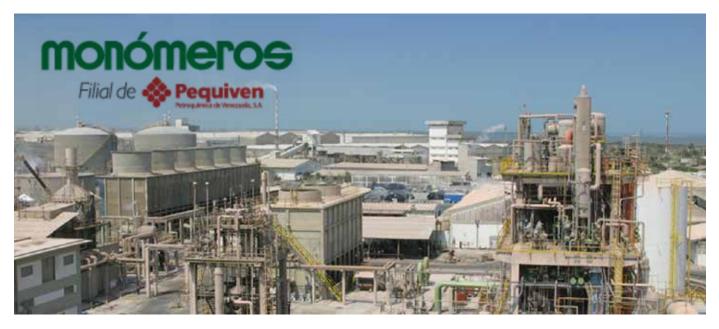
Monómeros Colombo Venezolanos' facility in Barranquilla, located on the north coast of Colombia.

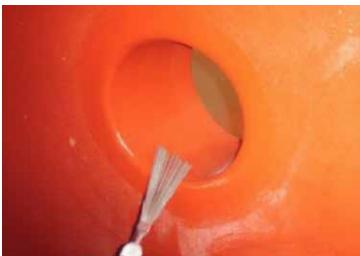
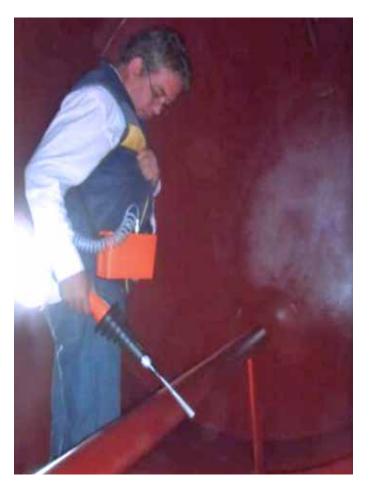
This Sulphuric Acid storage tank at Monómeros Colombo Venezolanos uses ChemLine® 784/32 coating for superior corrosion protection. Here, prior to being put into service, the coating in the tank is spark tested as part of a thorough inspection process.
